LUSCOMBE AIRPLANE CORPORATION  
West Trenton, New Jersey

ENGINEERING BULLETIN NO. 15

RECOMMENDED REPAIR FOR FUSELAGE SKIN CRACKS AT REAR WING SPAR

Aircraft affected: All Luscombe Model 8 Series up to and  
Including Serial No. 1789.

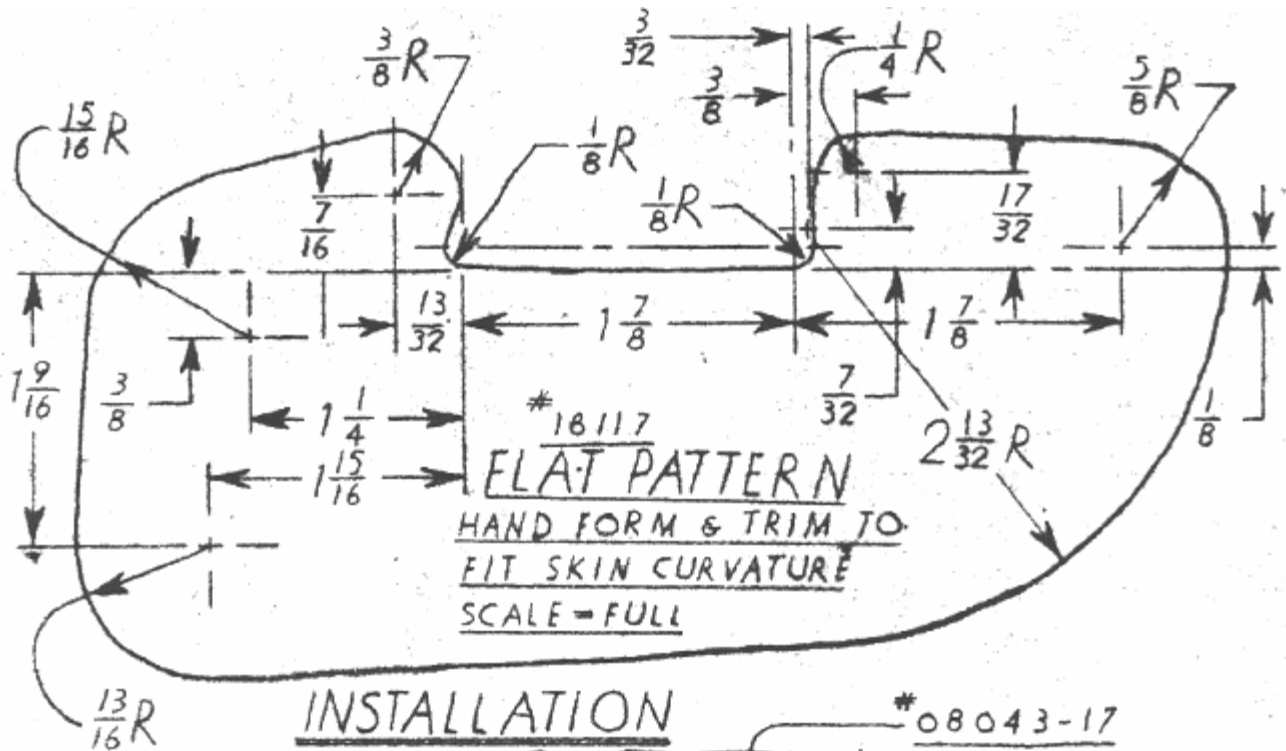
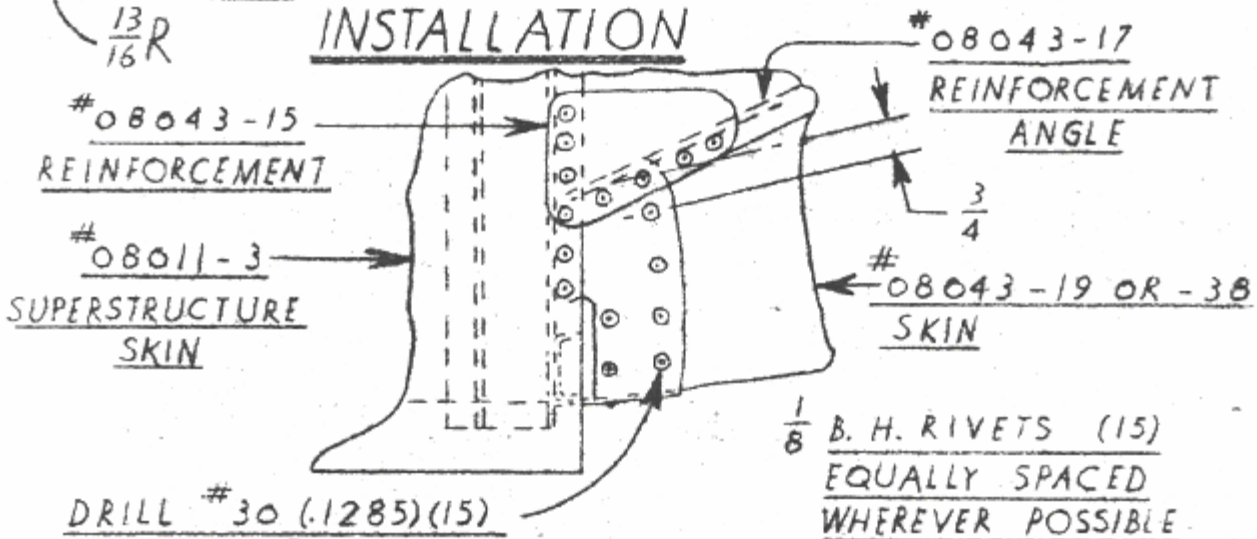
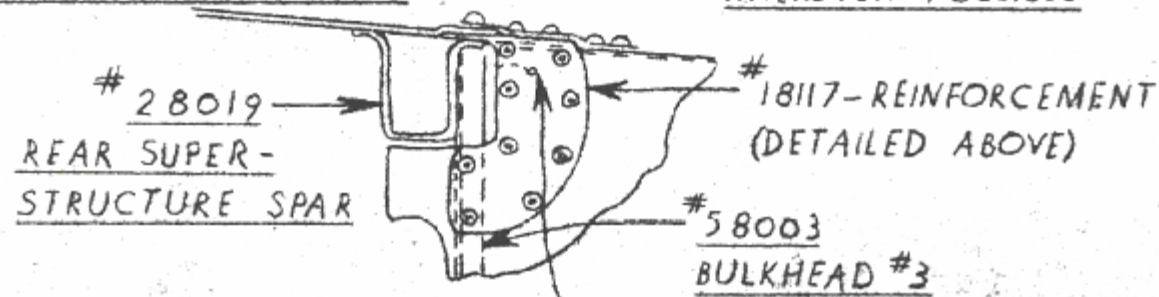
**INSTALLATION**

Skin cracks have occurred in the fuselage skin at the rear wing spar which have led us to add a reinforcement, part No. 18117, at our factory, and to recommend that you make the same change on any and all subject aircraft in your possession. The Civil Aeronautics Administration has been informed of this change, and it will probably recommend or insist that all Luscombe Aircraft showing evidence of cracks be repaired as illustrated on the following page.

RELIEVE #30 (.1285)(ALL CRACKS)

DRILL #30 (.1285)(15)
