LUSCOMBE AIRPLANE CORPORATION
West Trenton, New Jersey

ENGINEERING BULLETIN No. 16

RECOMMENDED REPAIR FOR CRACKS IN REAR FIN SPAR AT UPPER HINGE BRACKET

Aircraft affected: All Luscombe Model 8 Series up to and including Serial No. 1776

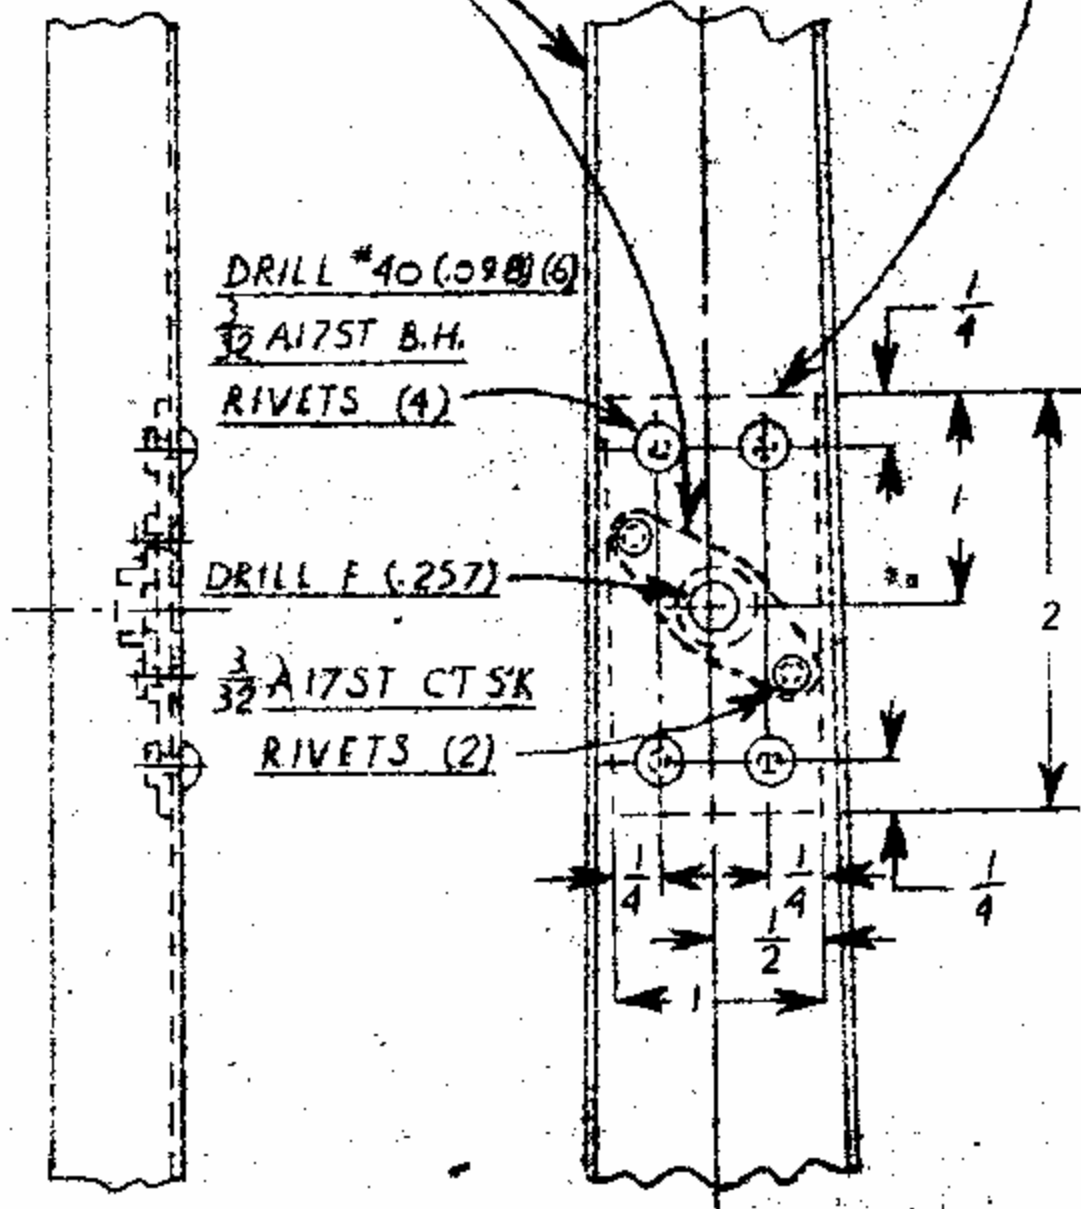
The occurrence of cracks on the rear fin spar at the upper hinge bracket has led to the addition of a reinforcement plate on all fin spars for new aircraft at our factory. The Civil Aeronautics Administration has been informed of these facts, and it will probably recommend or insist that all Luscombe Aircraft manufactured before this addition be inspected and that all aircraft having these failures be repaired as outlined below and illustrated on the accompanying page.

REAR FIN SPAR
LUSCOMBE PART
#38411

1. Should the reinforcement plate (Luscombe part #18451) be insufficiently large to fully cover all cracks, or should any crack be more than one-half inch long, the spar should be replaced.
2. Providing the spar is repairable, remove enough rivets to allow the fin skin to be peeled back sufficiently to allow room for a dolly, and remove anchor nut (AC 366-F428)
3. Relieve all cracks with a #30 (.1285) drill
4. Drill spar to match reinforcement plate
5. Rivet plate in place
6. Drill plate to match anchor nut
7. Rivet a new anchor nut in place
8. Replace covered rivets in skin

REINFORCEMENT PLATE -
LUSCOMBE PART #18451
MAT'L: .040 17ST ALC

PLATE NUT
AC.366-F42B
