LUSCOMBE AIRPLANE CORPORATION
West Trenton, New Jersey

ENGINEERING BULLETIN NO. 18

January 21, 1942

RECOMMENDED REPAIR AND ALTERATION FOR FRAYING RUDDER CABLES

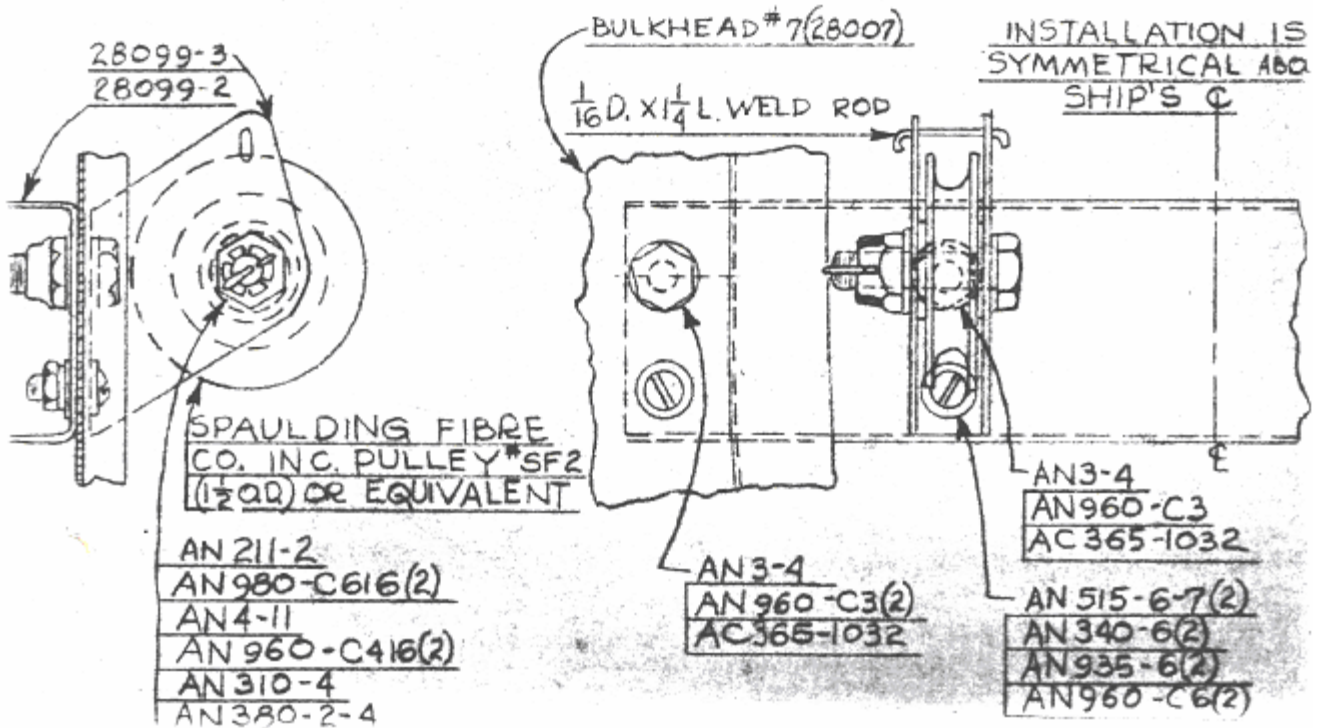
INSTALLATION DETAILS

The fraying of rudder cables at bulkhead #7 has led to the substitution of pulleys (LAC Drawing #28099) for the former fairleads (LAC Drawing #18058), and to our recommendation that you make the same change on any and all subject aircraft in your possession as soon as possible.

1. Replace the worn rudder cables with new ones, Luscombe Airplane Corporation parts #48501-2 and #48501-3.
2. Locate pulley bracket as per sketch, making sure the rudder cables do not rub against the skin slots, and drill #7 bulkhead to match.
3. Bolt bracket in place.
4. Safety cables over pulleys as per sketch and adjust.
