LUSCOMBE AIRPLANE CORPORATION
DALLAS 1, TEXAS

SERVICE BULLETIN NUMBER 3-46

SUBJECT: Installation of Rudder Return Springs, Model 8A
Serial Numbers 1925-3049

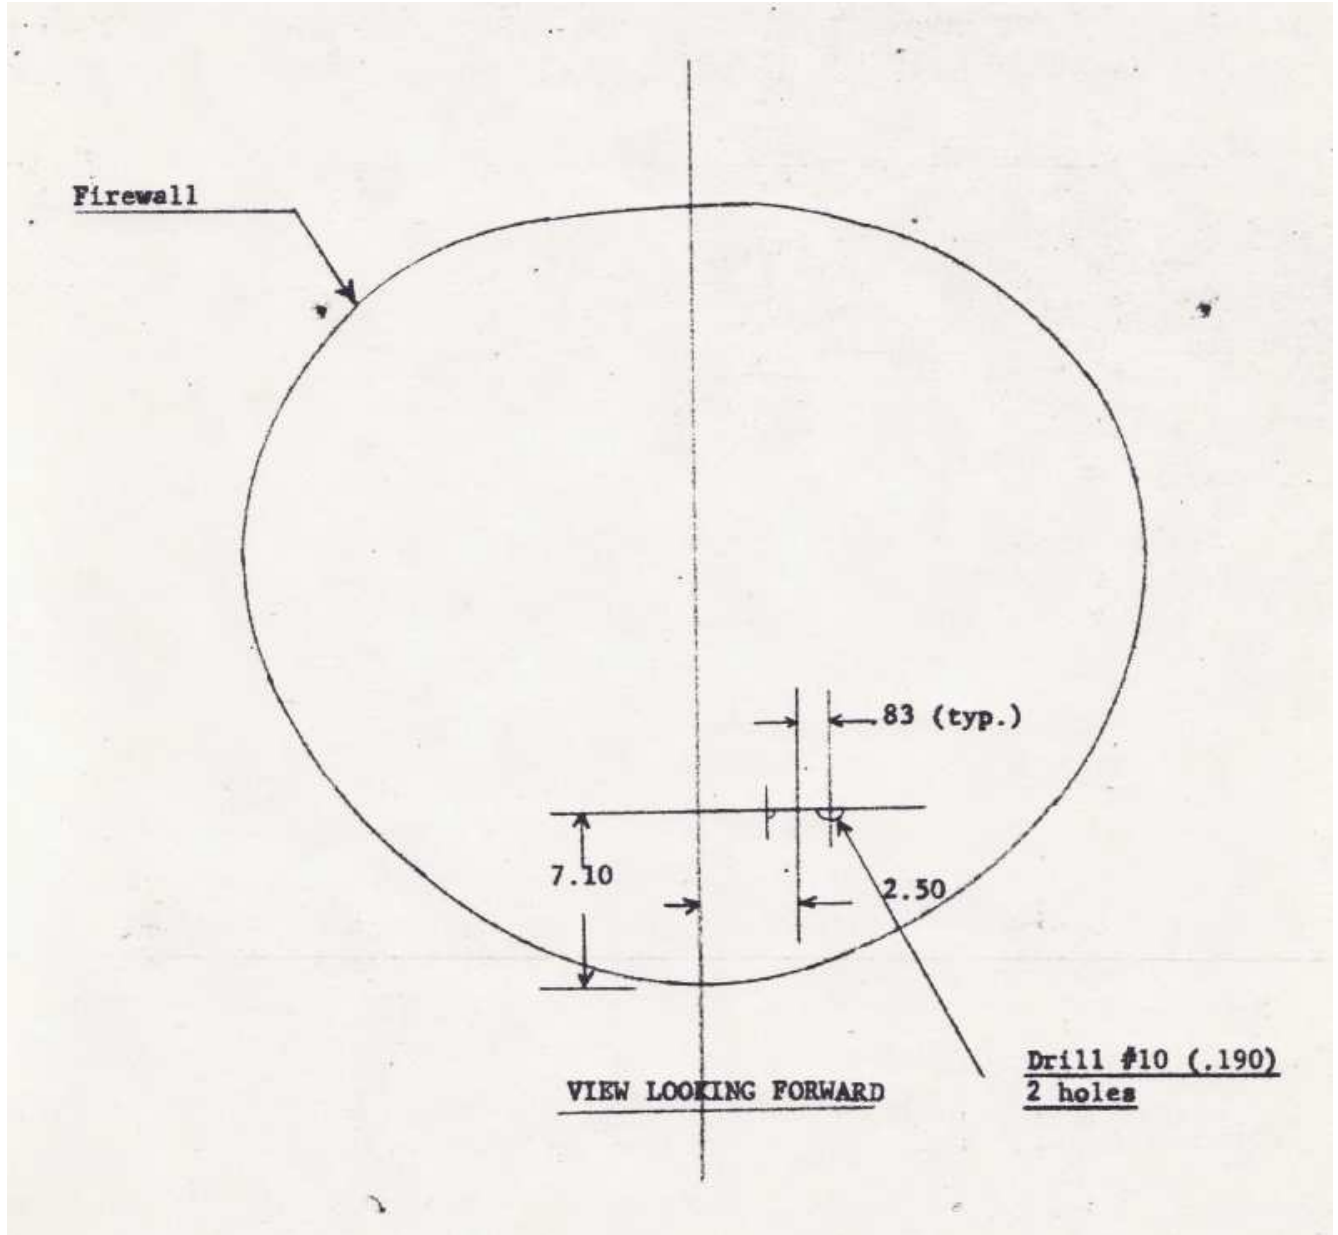
SUBJECT: Installation of Rudder Return Springs, Model 8A

In order to improve the directional stability characteristics of the Model 8A airplane, the changes described below and illustrated in the accompanying drawings are to be made as soon as possible.

1. Drill two #10 (.190) holes in firewall, located as per sketch.
2. Drill one #30 (.1285) hole in each rudder control horn, located as per sketch.
3. Install springs between firewall and rudder control horns, using AN42-6 bolts for connection springs to firewall. The spring tension may be varied slightly by carrying the arrangement of the washers on either side of the firewall until the rudder is held perfectly neutral by the springs.

NOTE: that the left spring is installed with a 1" steel link between the spring and the firewall.
