LUSCOMBE AIRPLANE CORPORATION  
DALLAS 1, TEXAS

SERVICE BULLETIN NUMBER 3-46

SUBJECT: Installation of Rudder Return Springs, Model 8A  
Serial Numbers 1925-3049

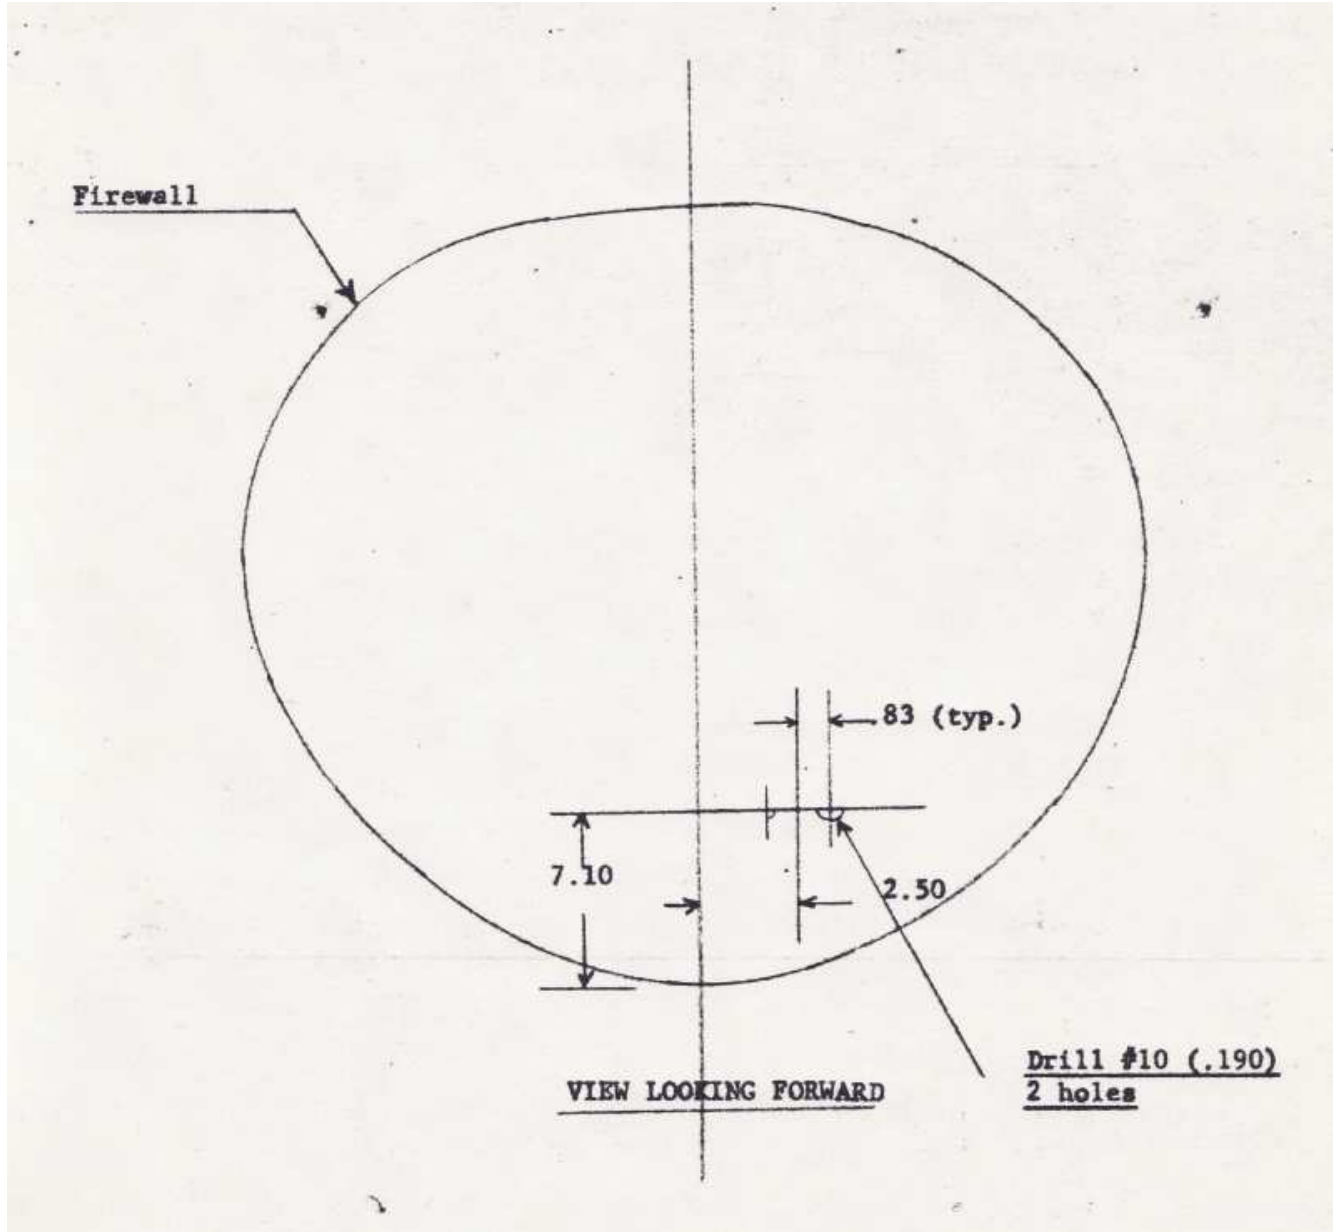
SUBJECT: Installation of Rudder Return Springs, Model 8A

In order to improve the directional stability characteristics of the Model 8A airplane, the changes described below and illustrated in the accompanying drawings are to be made as soon as possible.

1. Drill two #10 (.190) holes in firewall, located as per sketch.
2. Drill one #30 (.1285) hole in each rudder control horn, located as per sketch.
3. Install springs between firewall and rudder control horns, using AN42-6 bolts for connection springs to firewall. The spring tension may be varied slightly by carrying the arrangement of the washers on either side of the firewall until the rudder is held perfectly neutral by the springs.

NOTE: that the left spring is installed with a 1" steel link between the spring and the firewall.
