LUSCOMBE AIRPLANE CORPORATION
P.O. Box 2128, Dallas 1, Texas

SERVICE BULLETIN NUMBER 3-48

TO: All Silvaire Owners & Operators
FROM: Service Department
SUBJECT: Rework of Rear Spar Hinge Bracket #19421
SERIAL NOS. AFFECTED: 1925 - 6283 Inclusive

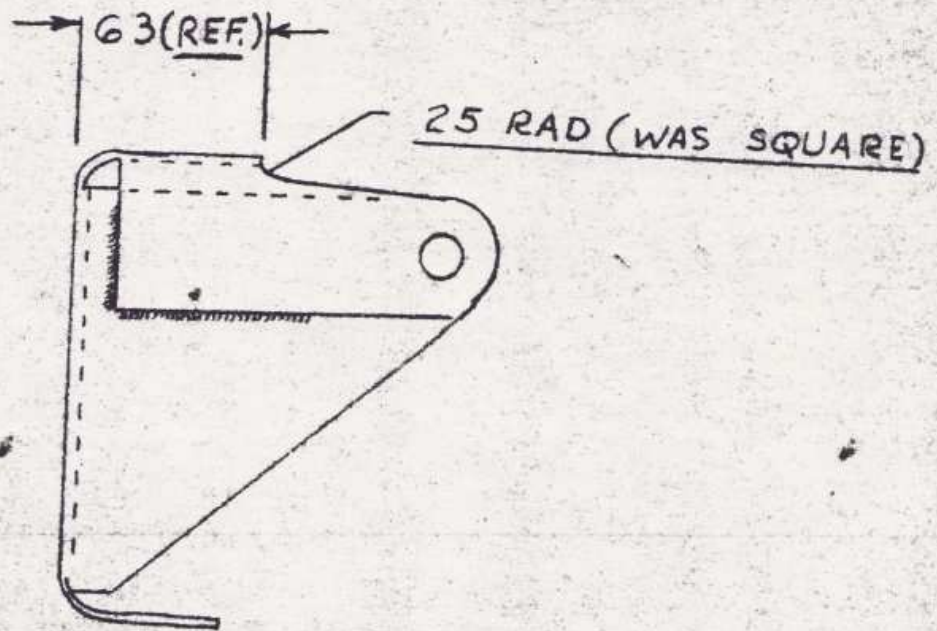
BULLETIN 3-48
7-10-48

Several cases of cracks developing in the side flanges of the stabilizer attaching bracket at the point of union with the top flange have been reported to this office.

The condition is not considered dangerous; however you are urged to carefully inspect all aircraft within the block of serial numbers noted, as soon as possible. Prevention of cracks may be accomplished by filing the corner noted in the attached sketch to a one-quarter (.250) radius.

If inspectio of the fitting indicates that replacement is necessary rather than rework to this bulletin, new fittings may be purchased through the Service Department. Silvaire Aircraft Co., P.O. Box 719, Fort Collins, Colorado
