LUSCOMBE AIRPLANE CORPORATION  
DALLAS, TEXAS

SERVICE BULLETIN 4-46

SUBJECT: Inspection of Rudder Pedal Horn

Model: 8A

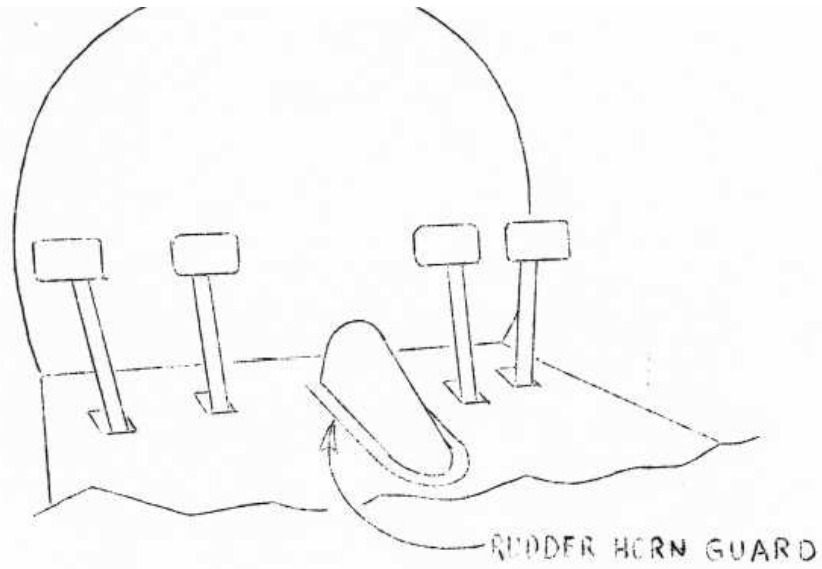
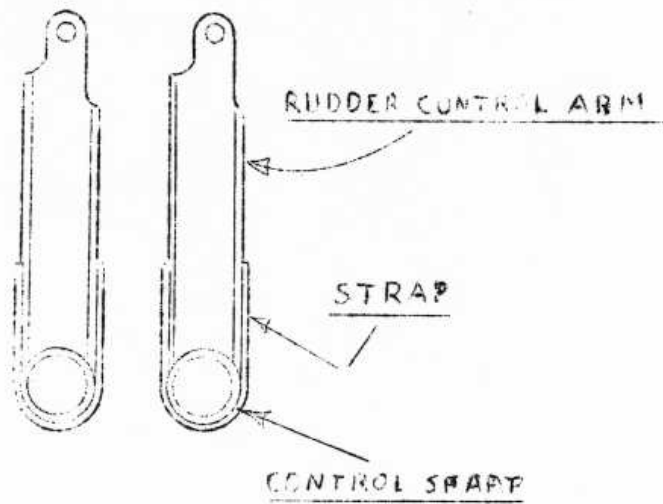
- (1) Remove the rudder horn guard from the cabin floor between the right and left sets of pedals (see attached sketch.)
- (2) Check the attachment of the rudder control arm on the torque tubes. The reinforcing steel strap should extend around the tube and be securely welded to both the fore and aft flanges of both rudder control arms.
