SERVICE BULLETIN NO. 4

Retyped March 2, 1960  
SILVAIRE AIRCRAFT CO.  
P.O. BOX 719  
FORT COLLINS, COLORADO

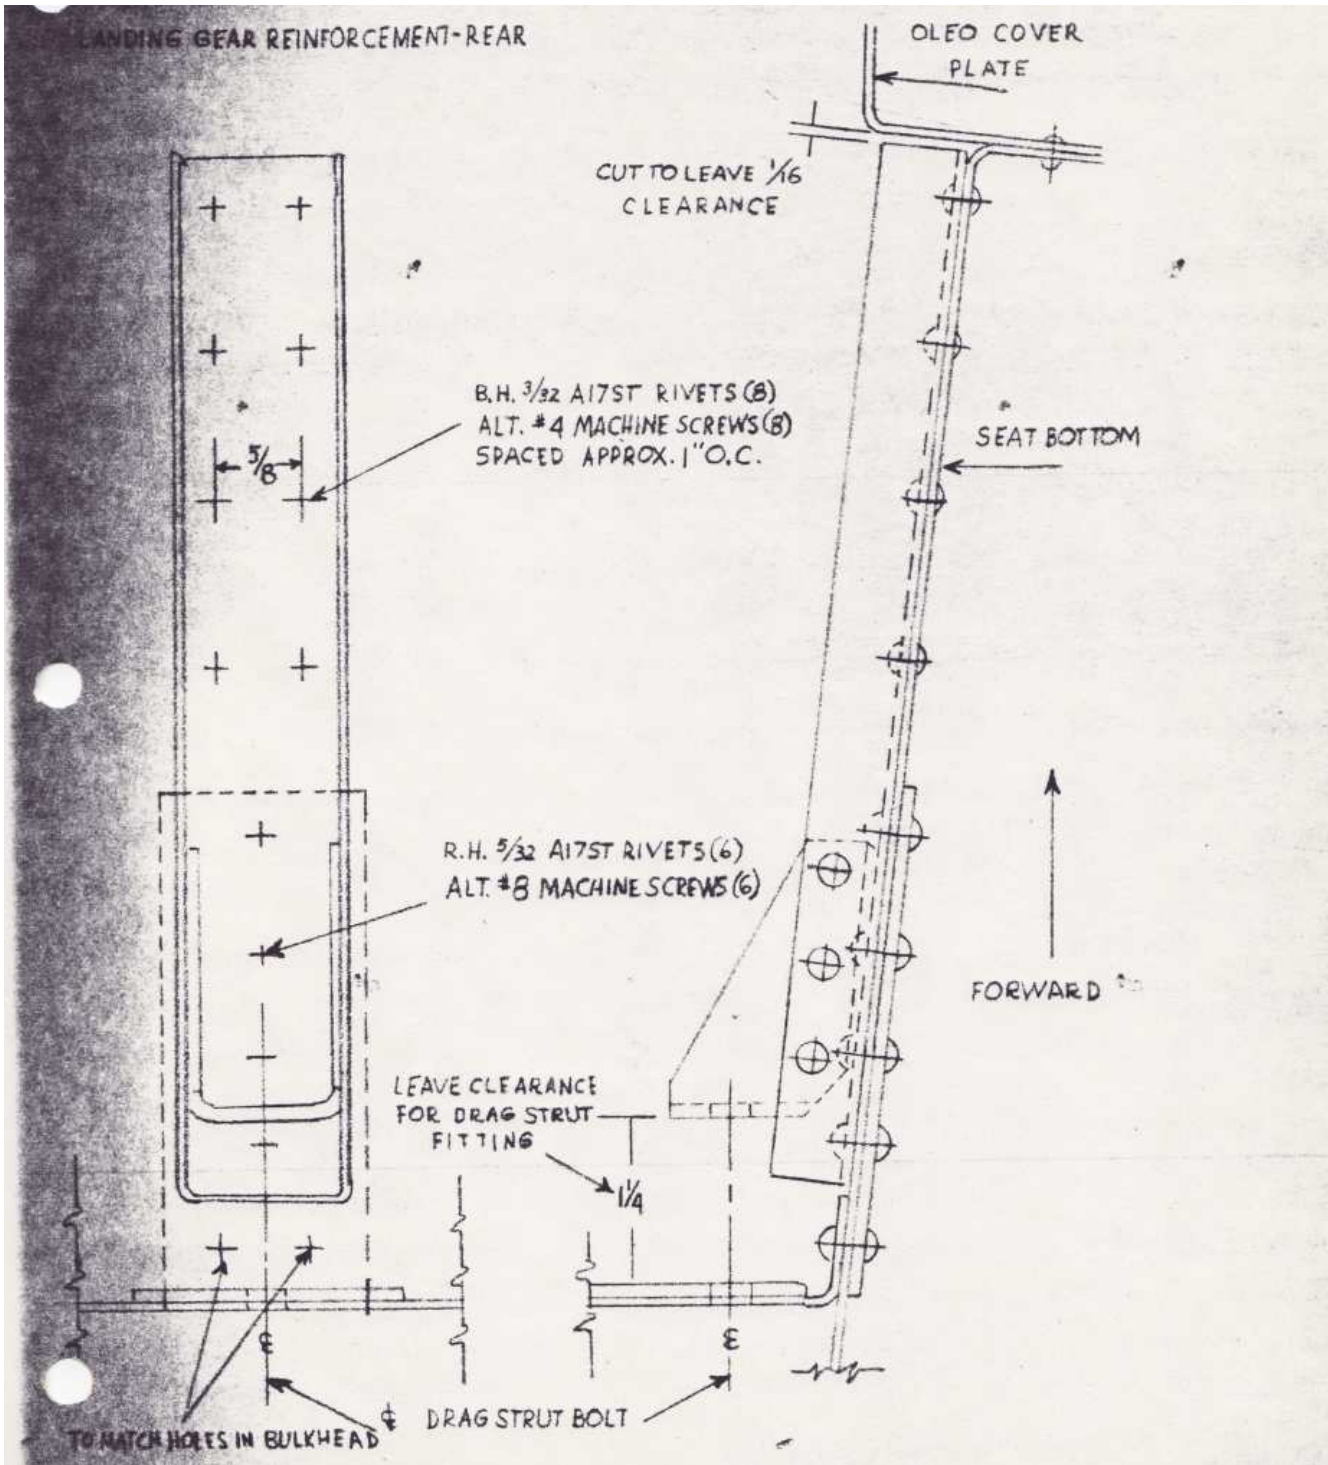
LANDING GEAR REINFORCEMENT-REAR

A report has been made to us of a fatigue failure on our Model "8" in the bulkhead to which the rear landing gear strut is bolted. The failure started as a crack in the bend of the top bulkhead flange, just over the landing gear attachment fitting. We therefore advise you to carefully inspect this place and if a crack is found get in touch with us immediately for instructions as to how to make the repair.

To lessen the danger of a fatigue failure occurring, a reinforcement fitting should be installed in your airplane as shown on the enclosed sketch. This fitting is to be installed on both sides of the airplane in accordance with the following instructions.

1. Remove from under side of seat the triangular shaped reinforcing sections which are approximately in line with landing gear fittings.
2. Cut off reinforcement fitting to proper length to fit under seat and line up with 5/16 hole in steel bracket with landing gear bolt, which passes through it. This may necessitate placing a shim between channel and seat bottom.
3. Rivet reinforcement to seat, being sure to include steel strap on top of seat as shown. If impossible to rivet, steel machine screws and elastic nuts or other approved locking device may be used as noted on sketch.

If your bulkhead is sound, make this installation at once to avoid the possibility of a more difficult repair job. If a crack has developed, do not make the installation until you receive further instructions.
