LUSCOMBE AIRPLANE CORPORATION

SERVICE BULLETIN NO. 5

February 27, 1939

TAIL TRAY REINFORCEMENT

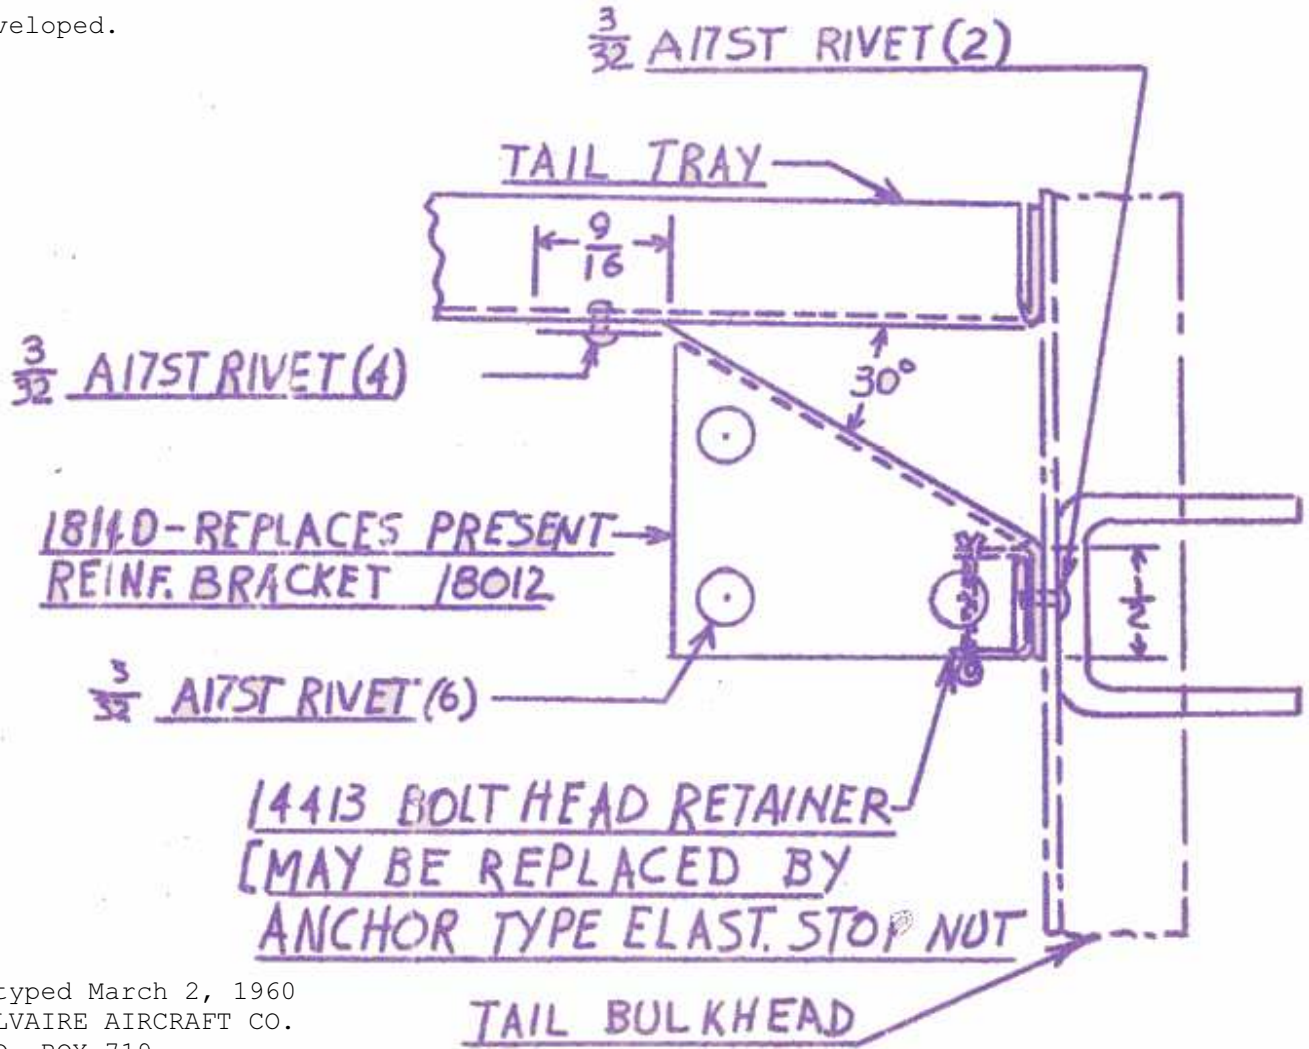
The tail tray is a horizontal bulkhead located in the tail of the fuselage just under the horizontal stabilizer. In two or three instances owners have reported cracks in this tray just forward of its attachment to the rear bulkhead. The repair for such damage is shown on the sketch. It is recommended that you make the replacement shown on your airplane, whether or not cracks have yet developed.
