**SERVICE RECOMMENDATION #2**

December 15th, 1993, REVISED September 9, 1997

**Applicability:** All Luscombe model 8 series aircraft. (models 8, 8A, 8B, 8C, 8D, 8E, 8F, and T-8F)

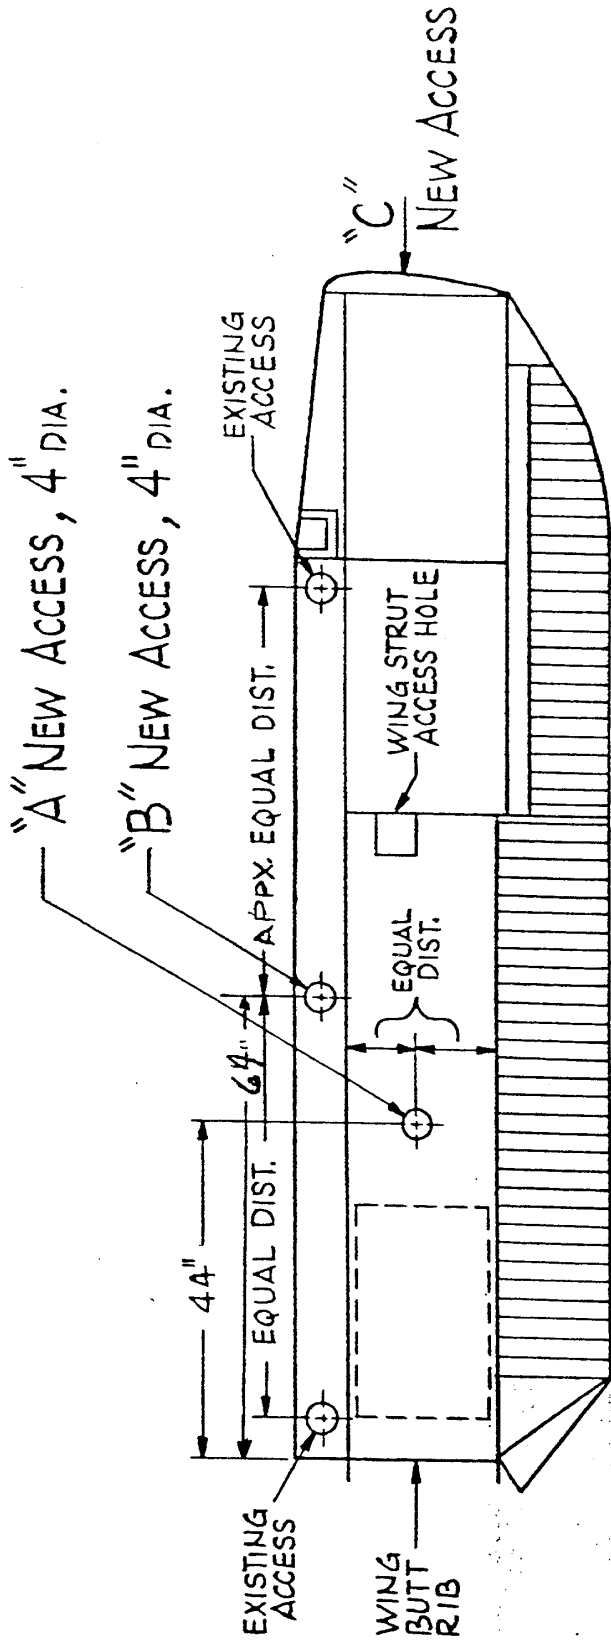
SERVICE RECOMMENDATION # 2	
SCALE: N.T.S.	APPROVED BY: <i>[Signature]</i>
DATE: 11-16-93	DRAWN BY D.J.W.
	REVISIONS
ADDITIONAL WING INSPECTION ACCESS HOLES	
	DRAWING NUMBER
	SK 18 PPI

Install two (2) additional wing inspection holes on each lower wing surface per DLAHF drawing SK 18, pp & pp2, (attached).

- a. Measure and mark the location center for one additional inspection hole midway between the spars on the lower surface of the wing, 44 inches outboard of the wing butt rib.

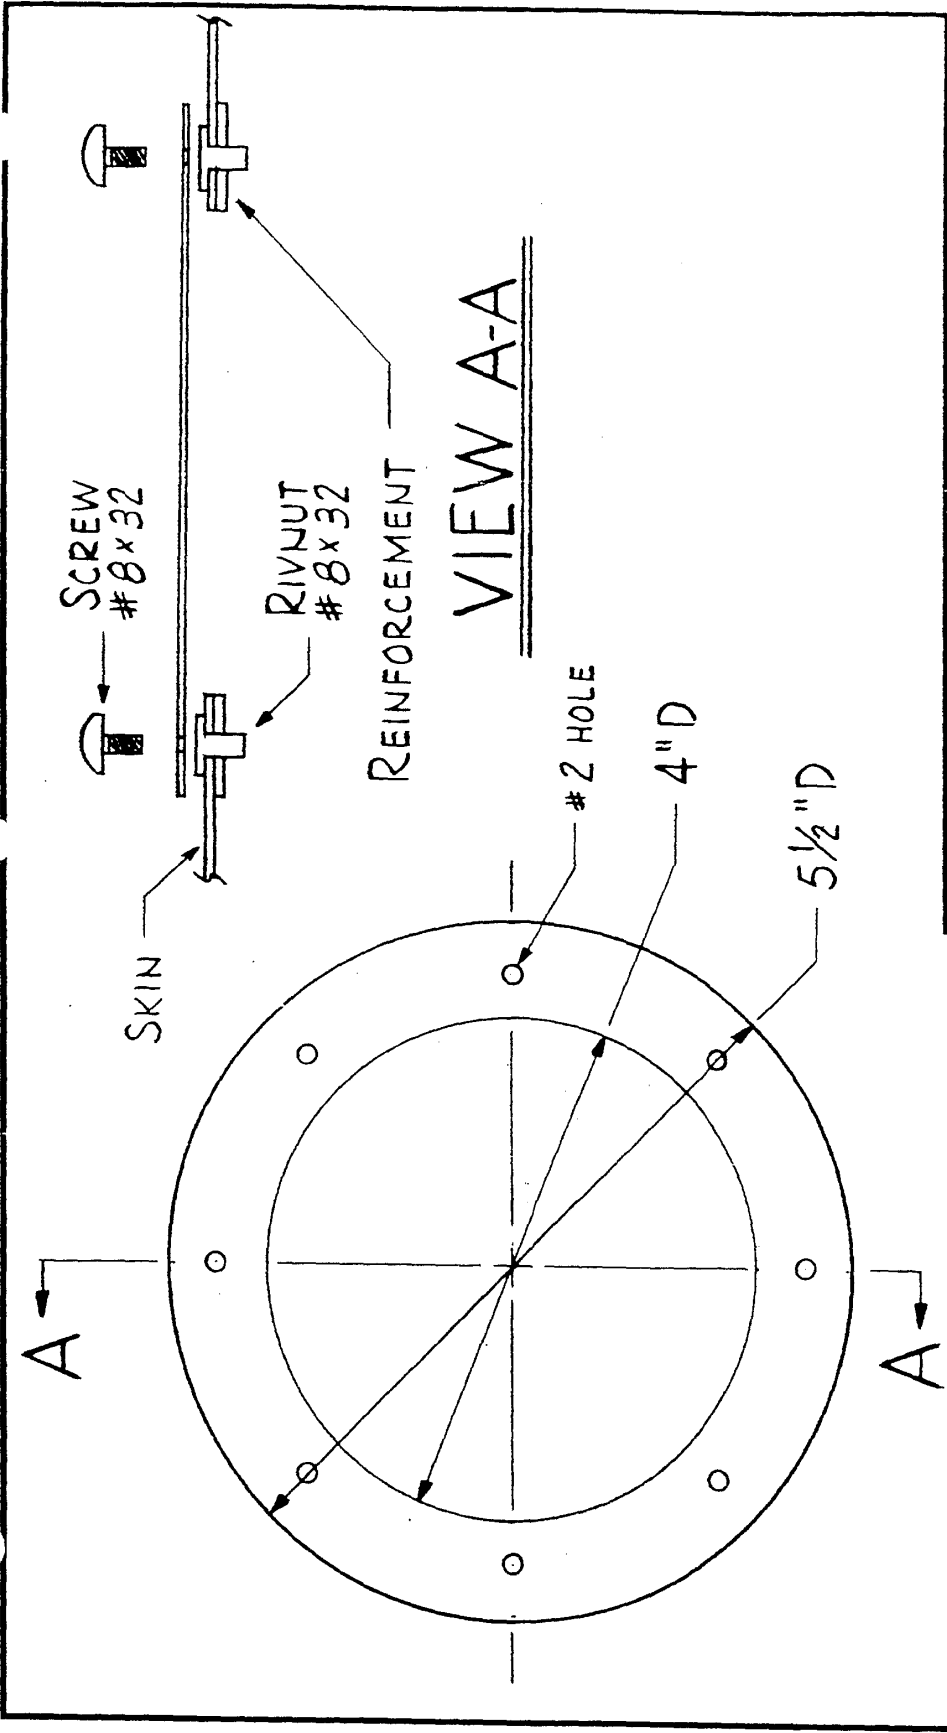
SERVICE RECOMMENDATION # 2	
SCALE: N.T.S.	APPROVED BY:
DATE: 11-16-93	DRAWN BY: D.J.W.
	REVISED
ADDITIONAL WING INSPECTION ACCESS HOLES	
ACCESS HOLE REINFORCEMENT	DRAWING NUMBER
	SK 18 PP2

- a9. Attach the coverplate with the screws provided, in accordance with drawing SK 1 8pp2.
- b. Measure and mark the location for one additional inspection hole forward of the leading edge spar on the lower surface of the wing, 64 inches outboard from the butt rib and centered at least 4 inches forward of the spar rivet line. To install the second inspection hole, (steps bi through b9), repeat steps a1-ag at the second location.
