LUSCOMBE AIRPLANE CORPORATION
West Trenton, New Jersey

ENGINEERING BULLETIN NO. 18

January 21, 1942

RECOMMENDED REPAIR AND ALTERATION FOR FRAYING RUDDER CABLES

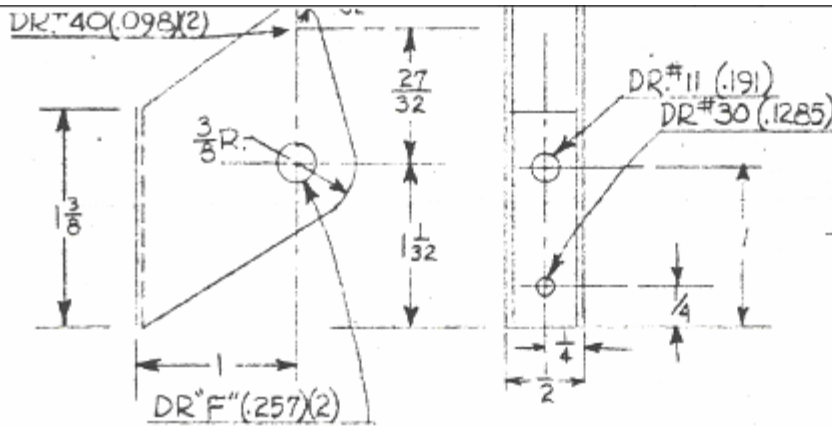
DETAILS OF 28099-3
MATERIAL=.040 17ST

The fraying of rudder cables at bulkhead #7 has led to the substitution of pulleys (LAC Drawing #28099) for the former fairleads (LAC Drawing #18058), and to our recommendation that you make the same change on any and all subject aircraft in your possession as soon as possible.

1. Replace the worn rudder cables with new ones, Luscombe Airplane Corporation parts #48501-2 and #48501-3.
2. Locate pulley bracket as per sketch, making sure the rudder cables do not rub against the skin slots, and drill #7 bulkhead to match.
3. Bolt bracket in place.
4. Safety cables over pulleys as per sketch and adjust.
