**SERVICE RECOMMENDATION #2**

December 15th, 1993, REVISED September 9, 1997

**Applicability:** All Luscombe model 8 series aircraft. (models 8, 8A, 8B, 8C, 8D, 8E, 8F, and T-8F)

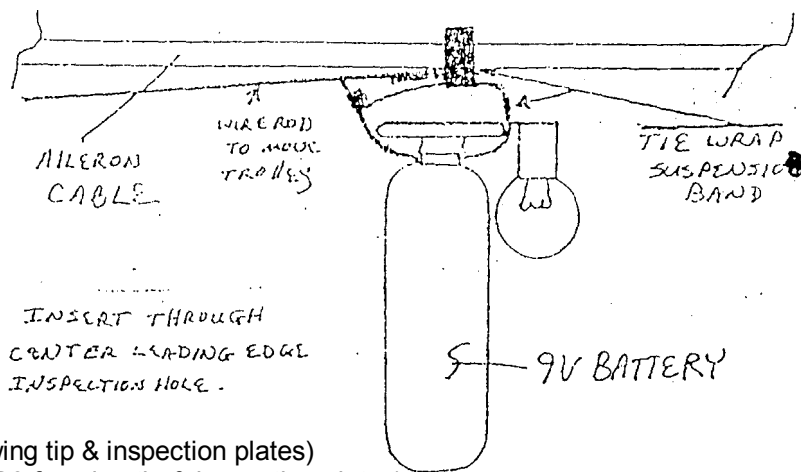
SERVICE RECOMMENDATION # 2	
SCALE: N.T.S.	APPROVED BY: <i>[Signature]</i>
DATE: 11-16-93	DRAWN BY D.J.W.
	REVISIONS
ADDITIONAL WING INSPECTION ACCESS HOLES	
	DRAWING NUMBER
	SK 18 PPI

**Purpose:** To facilitate the visual inspection of the internal wing front and rear spars for corrosion. This area is not readily visible in metal wings during routine maintenance due to a wing design defect; and the original manufacturer's failure to install routine inspection access to the internal wing areas. Service history of some of the Luscombe Model 8 series wings have shown intergranular corrosion in the spar extrusions. Other contamination and corrosion have also been discovered in many instances.

Install two (2) additional wing inspection holes on each lower wing surface per DLAHF drawing SK 18, pp & pp2, (attached).

- a. Measure and mark the location center for one additional inspection hole midway between the spars on the lower surface of the wing, 44 inches outboard of the wing butt rib.
